# Manhole Inspection Summary

Manhole # S23K\_\_036MH

**Location** Address: **1524 W Pratt St**

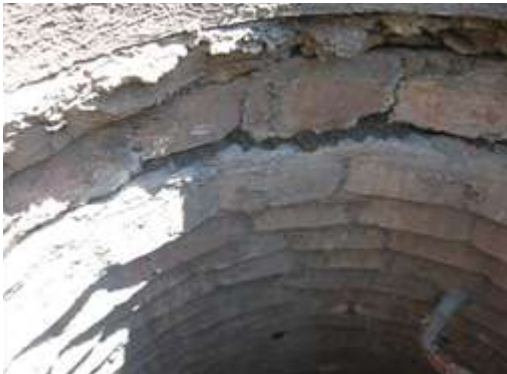
Defect 9

**Frame** Offset: **1.5** (in.) Condition: ☐ Sound ☐ Cracked ☒ **Leaks**

Infiltration: ☐ None ☒ **Joint** ☐ Cracks ☒ **Mortar** ☐ Roots ☐ Wall

infiltration frame-lid & frame -chimney gap  
missing mortarand cracked brick

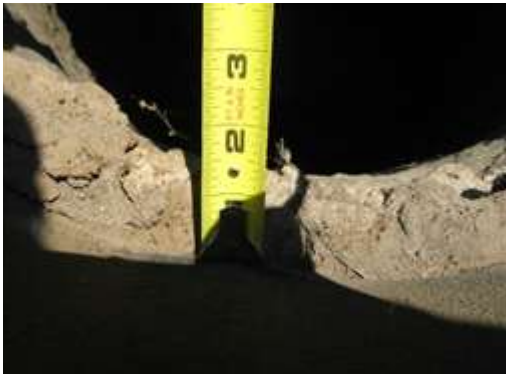
Defect 10

offset

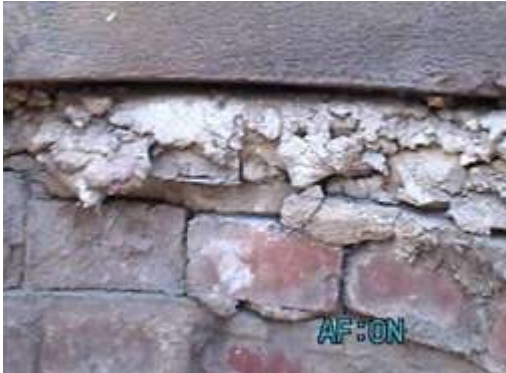
Defect 7

Condition: ☐ Sound ☐ Cracked ☐ Root Intrusion ☒ **Loose Brick** ☒ **Deteriorated**

loose bricks, misssing mortar, deteriated chimney

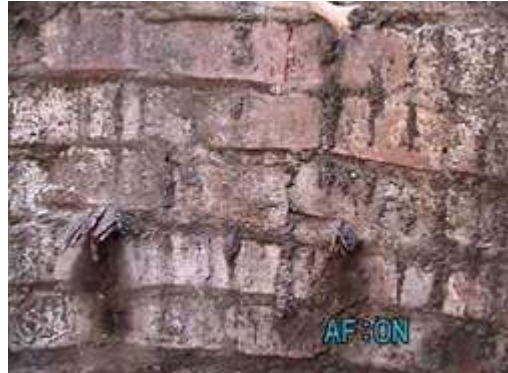
Defect 6

**Steps** Count: **6** Missing: **1** ☒ **Corroded**

missing rung

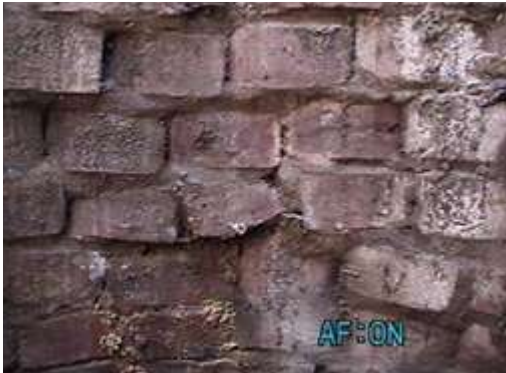
Defect 5

Condition: ☐ Sound ☐ Cracked ☐ Root Intrusion ☒ **Loose Brick** ☐ Deteriorated

loose bricks corbel

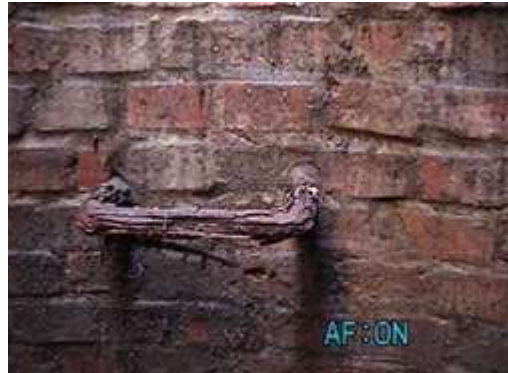
Defect 3

corroded rungs

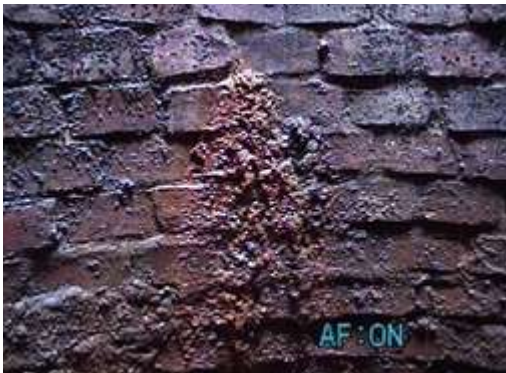
Defect 1

Infiltration: ☐ None ☐ Joint ☐ Cracks ☒ **Mortar** ☐ Roots ☒ **Wall**

corbel infiltration

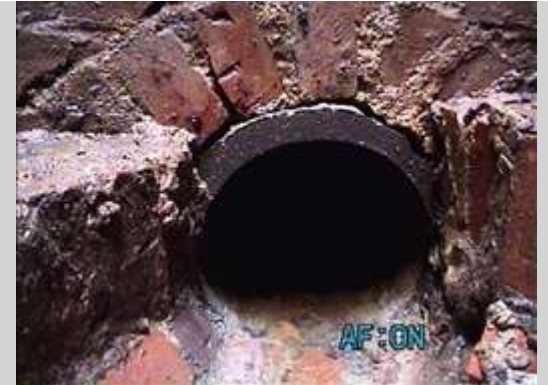
12 O'Clock Outflow

Pipe Height: **8.4** (in.) Rod and Bar (Angled)  
Pipe Material: **Clay** ☐ Pipe Lined  
Invert Depth: **11.06** (ft.) Flow Characteristics: **Slow**  
Deposits: ☒ None ☐ Mud ☐ Sludge ☐ Debris ☐ Grease  
Silt Depth: **0** (in.) Deposits Extent:  
Infiltration: **None** Pipe Seal Cond: **Sound**

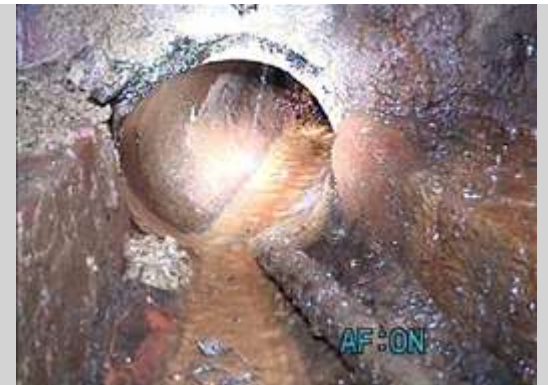
3 O'Clock Inflow

Pipe Height: **6** (in.) Rod and Bar (Angled)  
Pipe Material: **Clay** ☐ Pipe Lined  
Invert Depth: **10.49** (ft.) Flow Characteristics: **Slow**  
Deposits: ☒ None ☐ Mud ☐ Sludge ☐ Debris ☐ Grease  
Silt Depth: **0** (in.) Deposits Extent:  
Infiltration: **None** Pipe Seal Cond: **Sound**

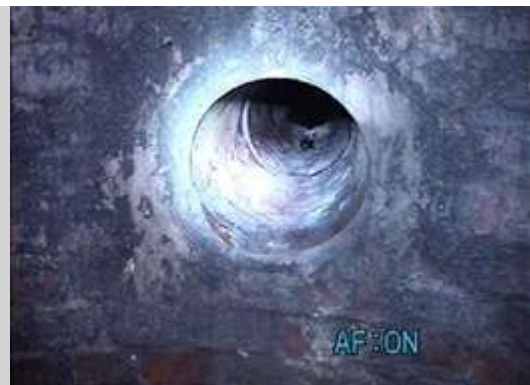
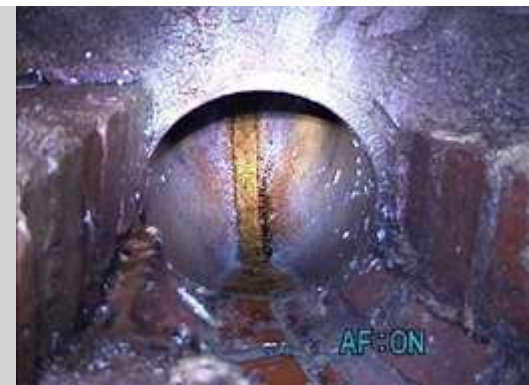
9 O'Clock Inflow

Pipe Height: **8.4** (in.) Rod and Bar (Angled)

Infiltration: **None** Pipe Seal Cond: **Sound**
